## F-111 Adhesive Bonded Repairs Assessment Program - Progress Report 1: Analysis of FM300 Repairs

*Eudora S. Y. Yeo and Andrew N. Rider*

DSTO-TR-2849

# F-111 Adhesive Bonded Repairs Assessment Program - Progress Report 1: Analysis of FM300 Repairs

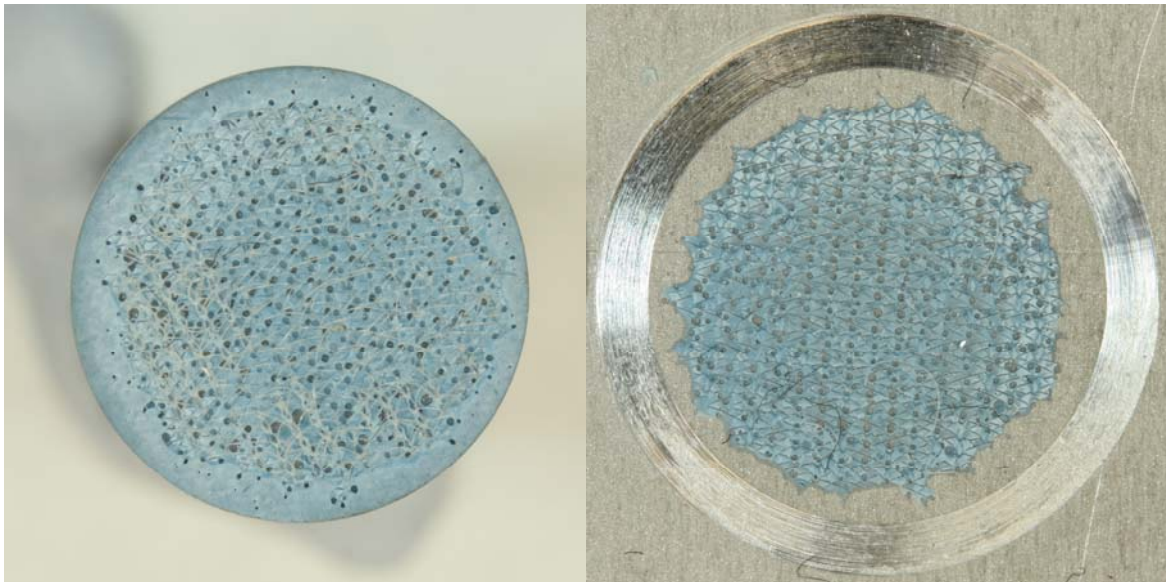
Figure 5 shows the failure surfaces from a 0° test from the second set. This type of failure was not uncommon, with what appears to be adhesion failure in a ring around the edge of the stub. As the test specimens were carefully manufactured and tested in controlled laboratory conditions, the adhesive having been cured and tested within 24 hours and not exposed to any degrading environment, adhesion failure is unlikely. It is possible that this failure surface shows the effect of peel, where the adhesive tends to remain bonded to the stiffer stub and peels away from the more flexible substrate due to the highest strain in the adhesive occurring at the edge of the adhesive layer, close to the flexible substrate.

The failure surfaces of stubs prepared with unstaged adhesive (Figure 5) showed high levels of bondline porosity. General observation of a large number of stubs from tested repairs indicated that bondline porosity was prevalent and could be quite high. The porosity is expected given most repairs were conducted using vacuum bag pressurisation. The results in Figure 4 indicate that porosity may not have any effect on the strength of an

Figure 5 Failure surfaces from a 0° test from the second set with the stub on the left and the substrate on the right. The apparent adhesion failure may actually be the effect of peel in the test configuration. Note that this failure surface shows quite a lot of small voids, which is typical of unstaged adhesive.

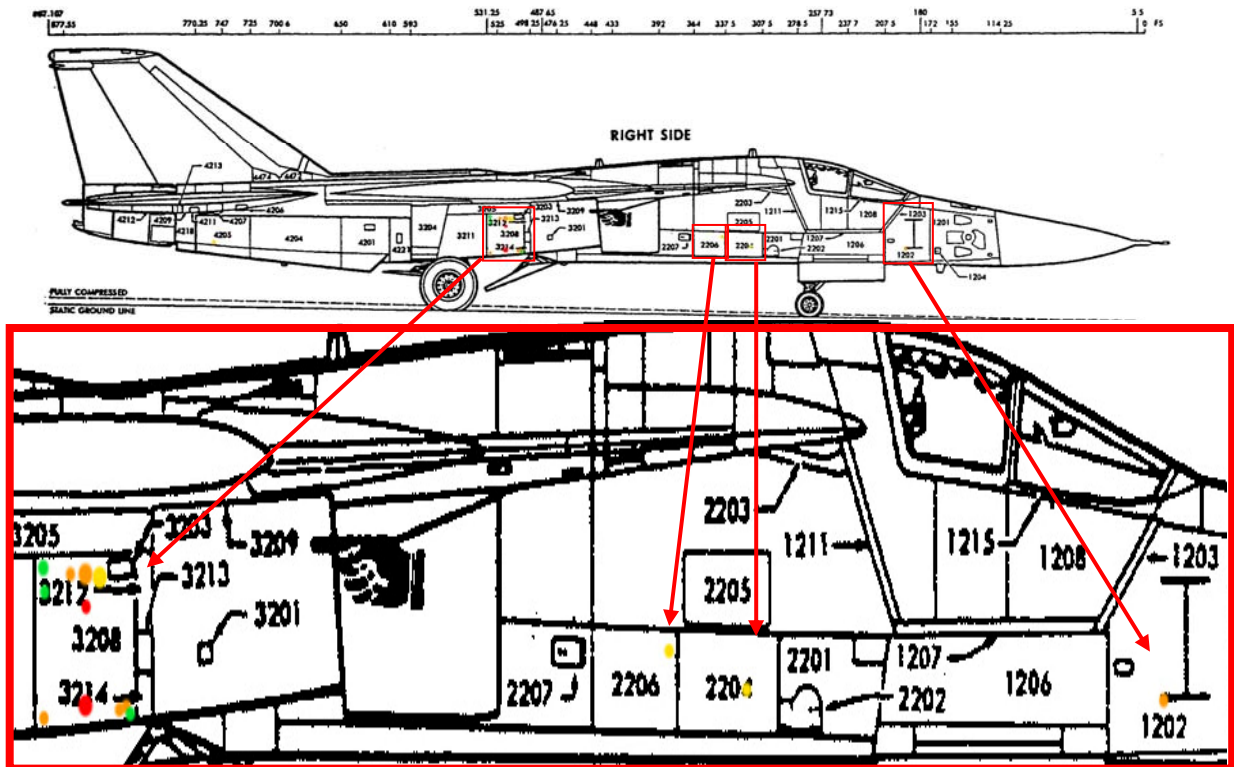
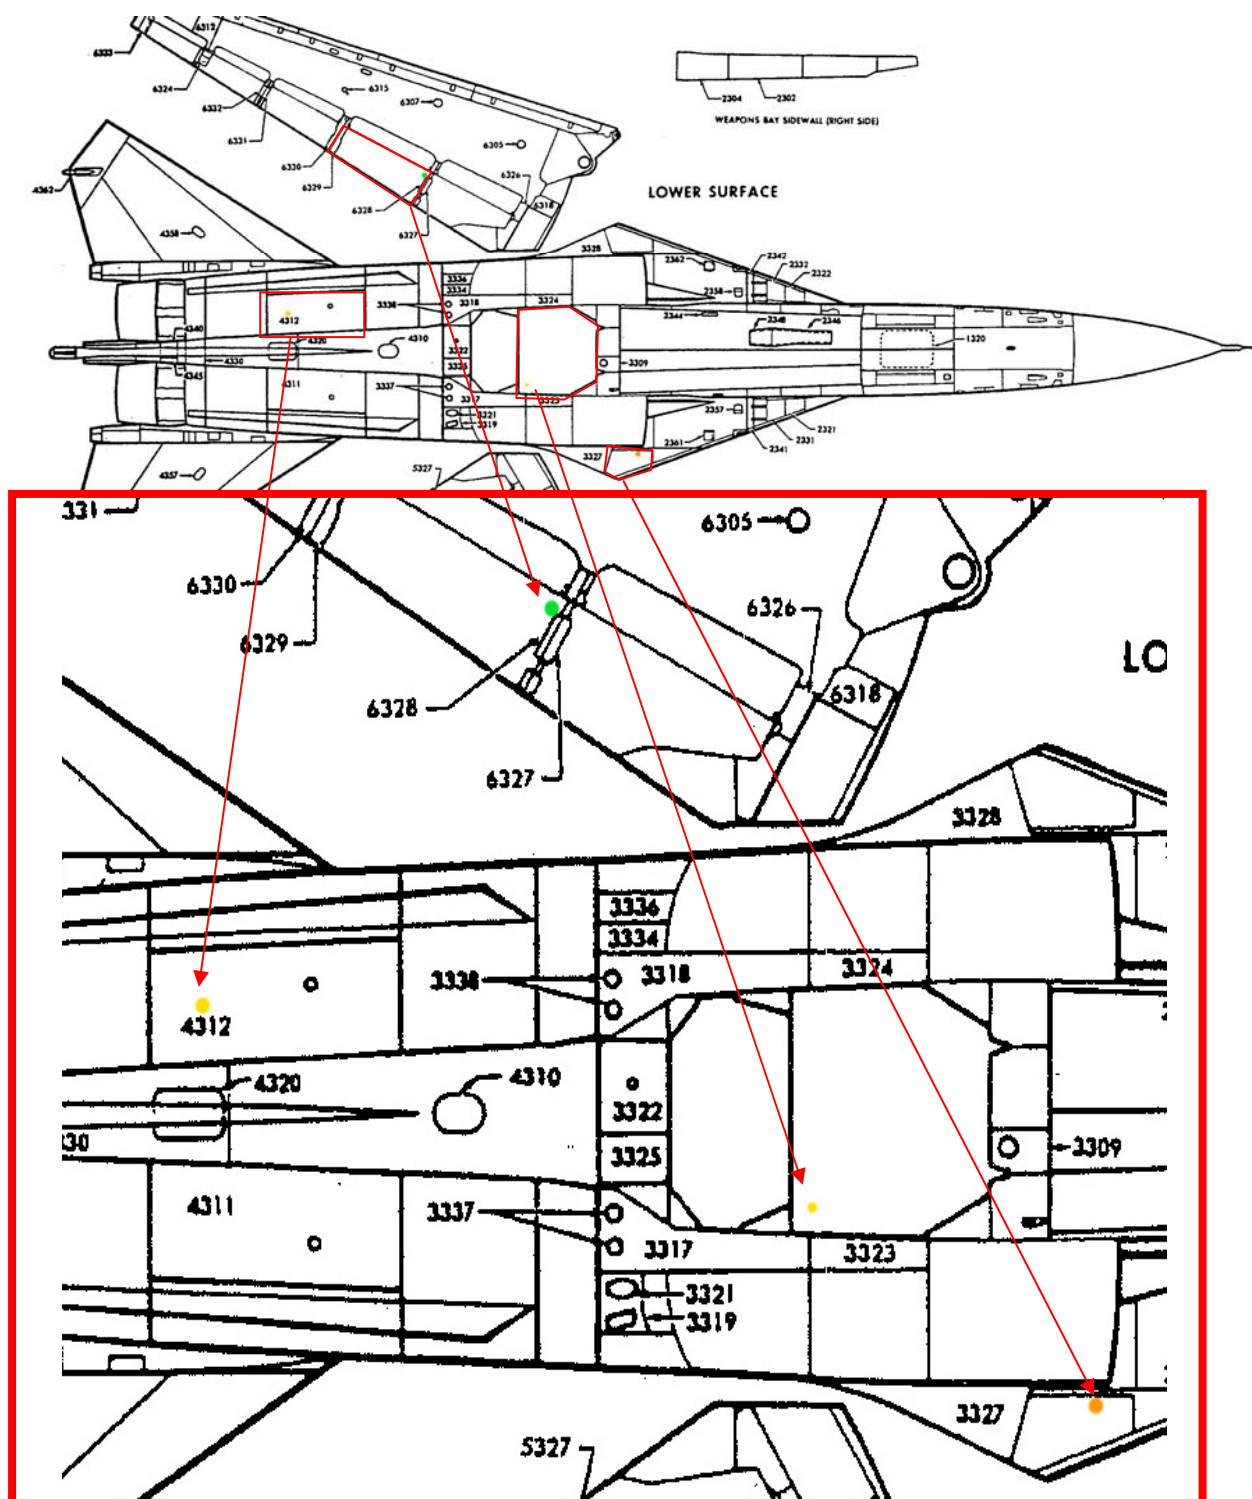
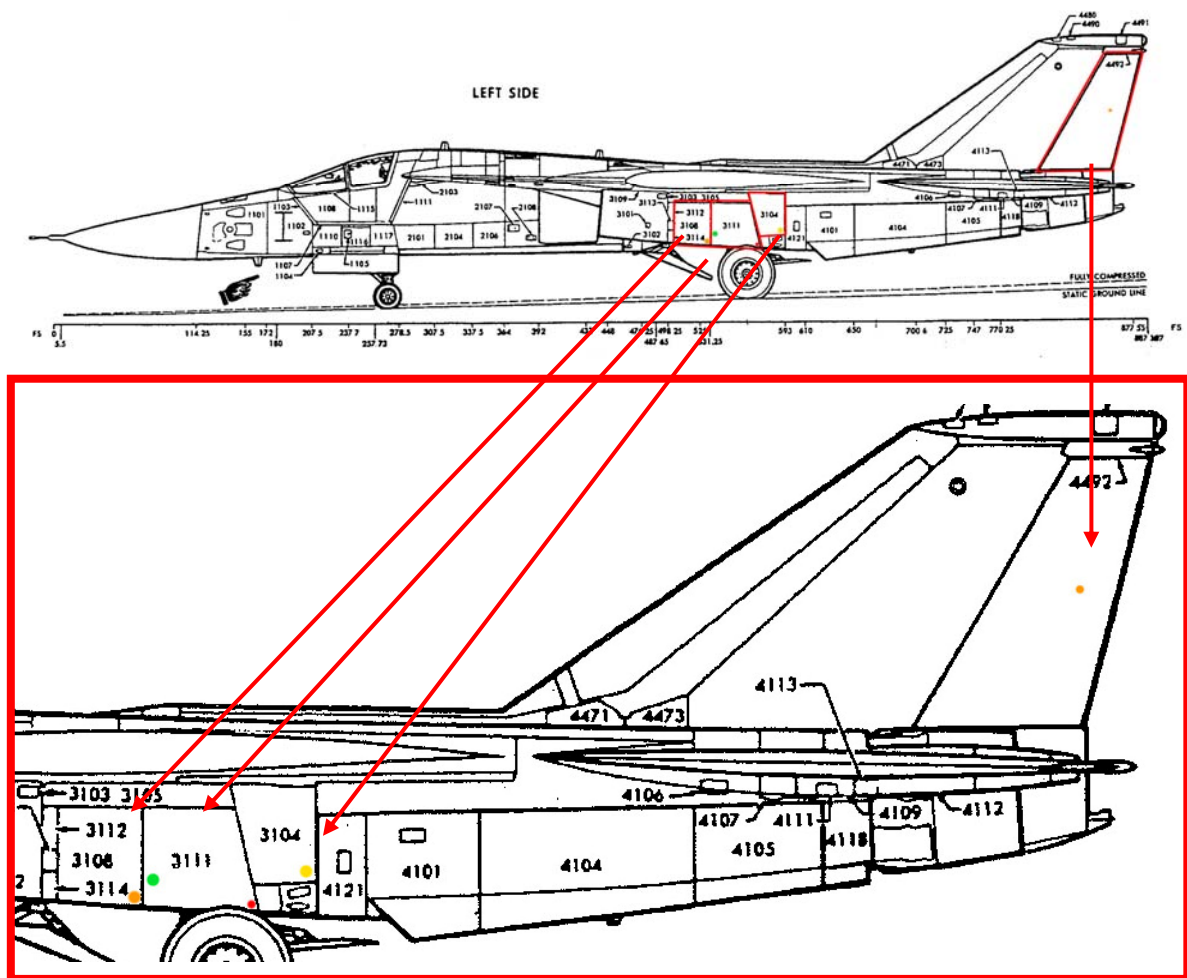
Close inspection of the location of the seven low strength (red) repairs suggests that most were located on components which had a higher degree of surface curvature. The low strength repairs were on panel 3208 (RHS) (two repairs), the rotating glove panel (panel 3424 upper surface), panel 3425 (upper surface), panel 3111, the inboard leading edge flap (upper surface), and the saddle tank. As most of the repairs analysed existed on the upper surface of the aircraft, it is not possible to determine a correlation between repair location and strength. However, the HSTABs had a considerable number of repairs on upper and lower surfaces near leading and trailing edges and did not exhibit any trend in repair strength with location. The surfaces with higher degrees of curvature may have some sensitivity to measured strength due to misalignment of the piston head being more likely, as indicated in Figure 2. However, the repairs on similar components in close proximity to the low strength repairs exhibited acceptable strength, which would suggest that component geometry was not a major factor influencing the measured repair strength. Further analysis of these low strength repairs will be provided in following sections.

Figure 9 Location of inspected FM300 repairs on the aircraft. Red markings denote repairs with a low strength (less than 10 MPa), orange and yellow markings represent medium strength repairs, and green markings represent high strength repairs (greater than 20 MPa).

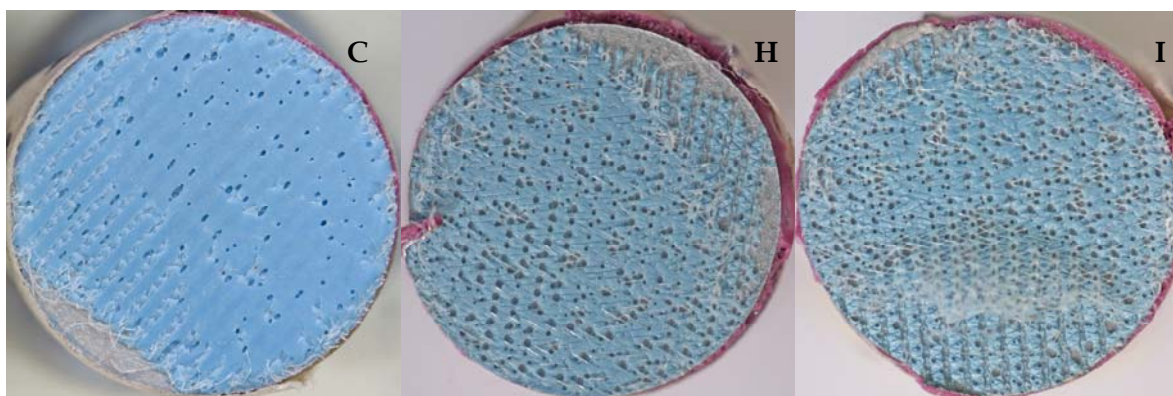
Specifically, repair number five from A8-143 had 10 pull stub tests carried out and 9 of the 10 tests from this repair had strengths below 10 MPa. The low strength repair location on panel 3208 was identified in Figure 9. Table 3 shows a detailed analysis of each of the pull-stub tests from repair 5 on A8-143. It was noted that most stubs exhibited higher levels of voiding than were previously observed on average strength stubs and that some evidence of adhesion failure was noted, shown in Figure 14. The strength below 10 MPa is believed to represent a reduction in strength from the typically applied repair, with high voiding levels suggesting deficiency in the application process, whereby either high humidity

*Figure 14 Test stubs C, H and I from repair A8-143-05. "C" shows the smooth surface typical of adhesion failure, while H and I show heavy voiding.*

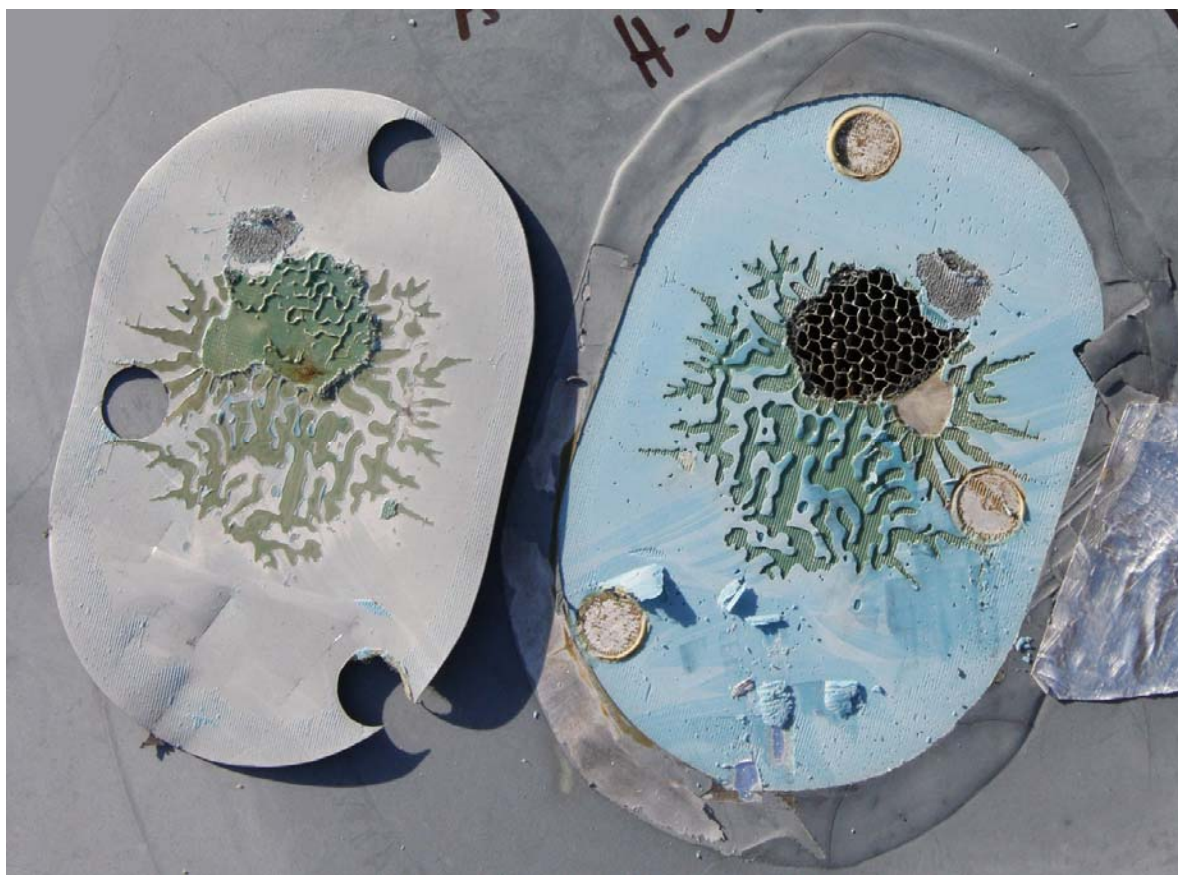
A total of 21 stubs showed heavy voiding associated with lines or tracks that had emanated from the central core region. These indications are highlighted in green in Table 3 and Table 4. A core repair requires cleaning by solvent flushing, followed by drying to remove the solvent. The heavy void tracks, an example of which is shown in Figure 17, are indicative that inadequate drying of the core had occurred prior to the elevated temperature cure of the FM300.

*Figure 17 Repair 514-28 shows heavy voiding emanating from the repaired core, indicative of inadequate drying following cleaning.*

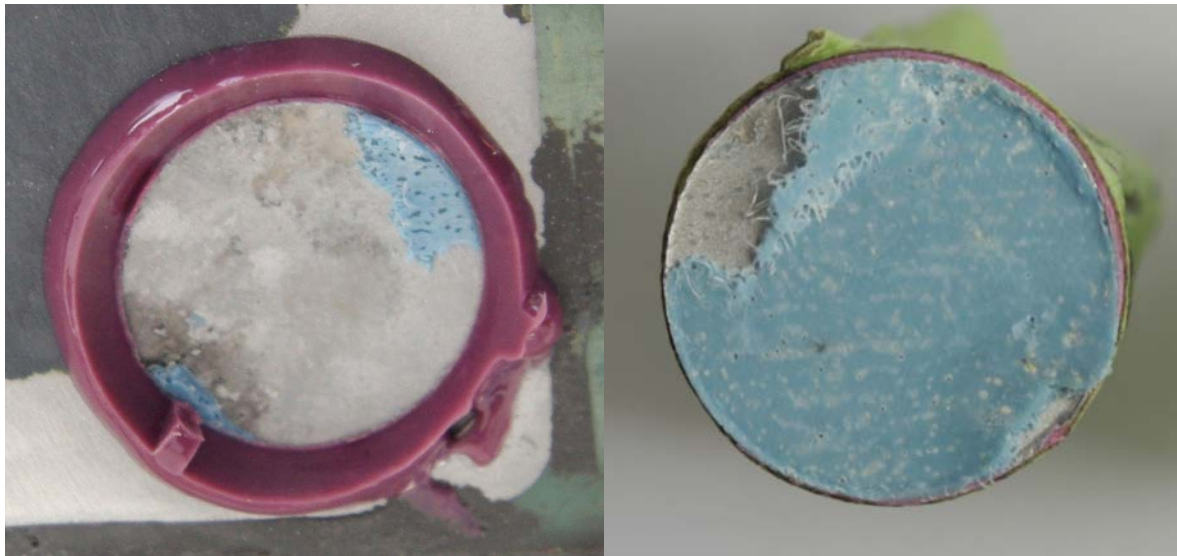
There were 6 stubs which indicated localised corrosion had occurred, including the lowest stub strength recorded for the filtered dataset, which was stub 11D on A8-514. Photographs of the test stub are shown in Figure 18. Inspection of this repair indicated that corrosion was in a very localised area where the low strength stub was pulled, whereas the stub pulled in an area representative of the unaffected region had a strength over 20 MPa. This indicates that the overall repair strength was satisfactory, but localised corrosion had led to significant bond strength reduction. Potentially, the long term storage of the aircraft in an outdoor location, and a long period without maintenance prior to the repair inspection (records indicate that the aircraft had been taken out of service seven years prior to inspection), had led to the corrosion of the repair due to deterioration of the protective paint layer and sealant. Nevertheless, the localised corrosion has clearly developed at a very slow rate and would be identified readily during normal maintenance of the aircraft.

*Figure 18 Test area exhibiting corrosion (stub 11D on A8-514). The aircraft side is shown on the left, and the test stub (removed doubler) on the right.*

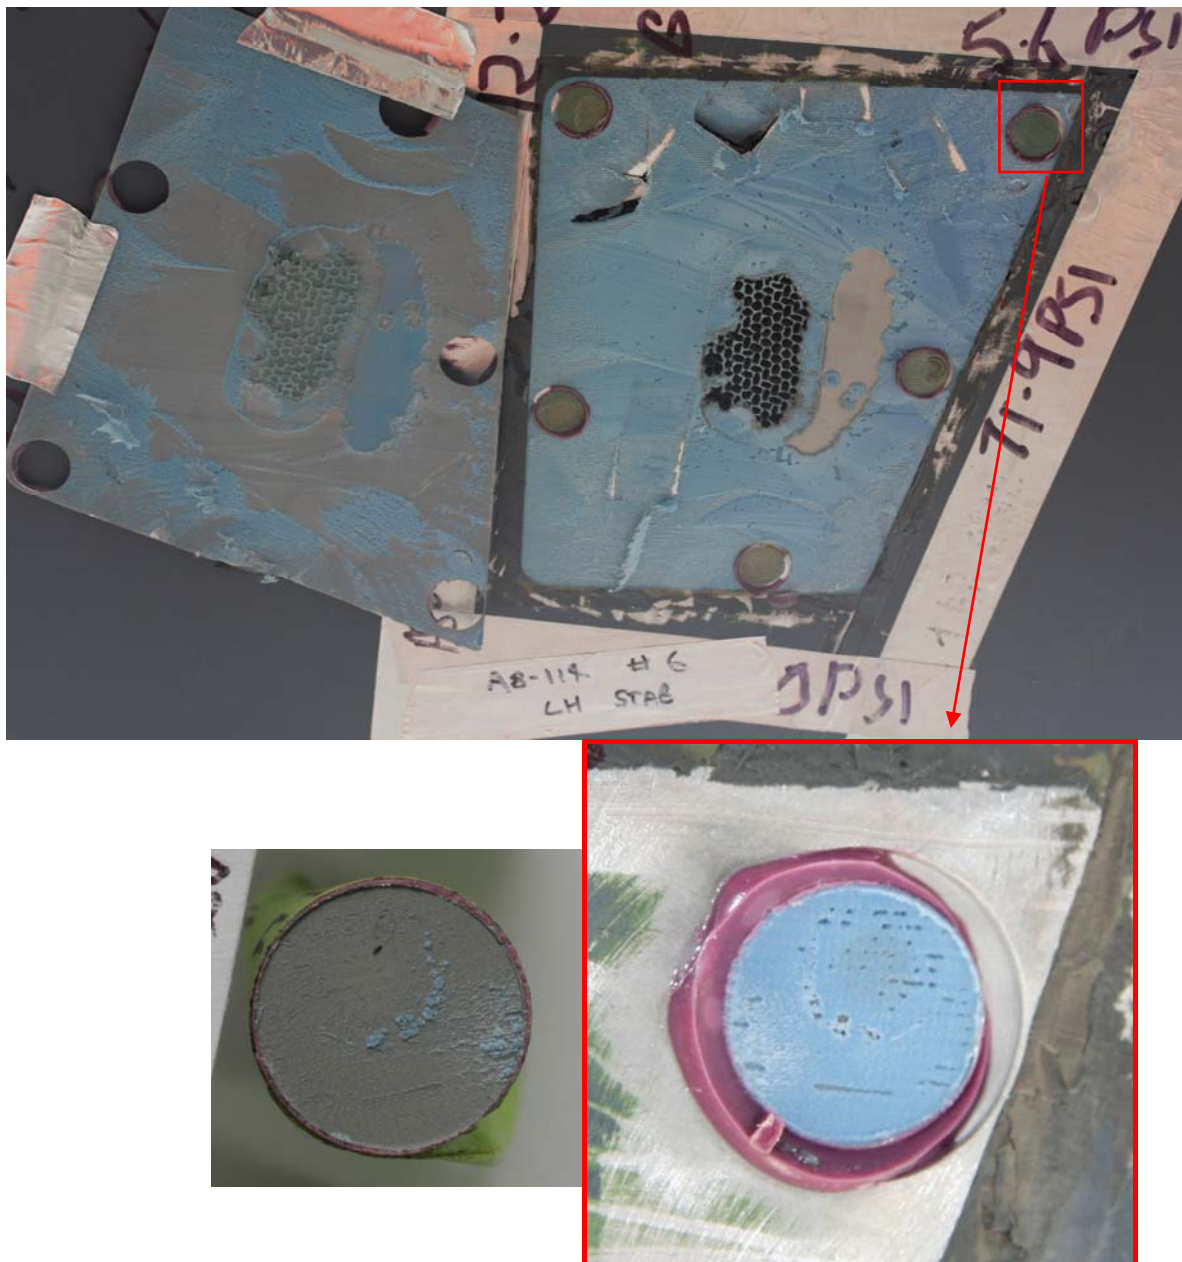
Amongst the lowest strengths observed were stubs for which there were apparent adhesive wetting problems, highlighted in blue in Table 4. Cases where the adhesive has not wetted either the doubler or aircraft skin are indicative of inadequate vacuum pressure being applied during the repair. An example is shown in Figure 19. In this particular repair, the adhesive has not come into contact with the aircraft skin in the area immediately to the right of the core insert. In other areas, such as the enlarged view of one test area and matching stub, the adhesive has come in contact with both faces but has wetted poorly. The low strength of these areas suggests that whilst it was relatively unusual, poor wetting was one of the more serious problems that could affect overall repair strength.

Figure 19 An example of poor wetting, with bare aluminium shown to the right of the core insert. In other areas the adhesive has come in contact with both faces but has wetted poorly.

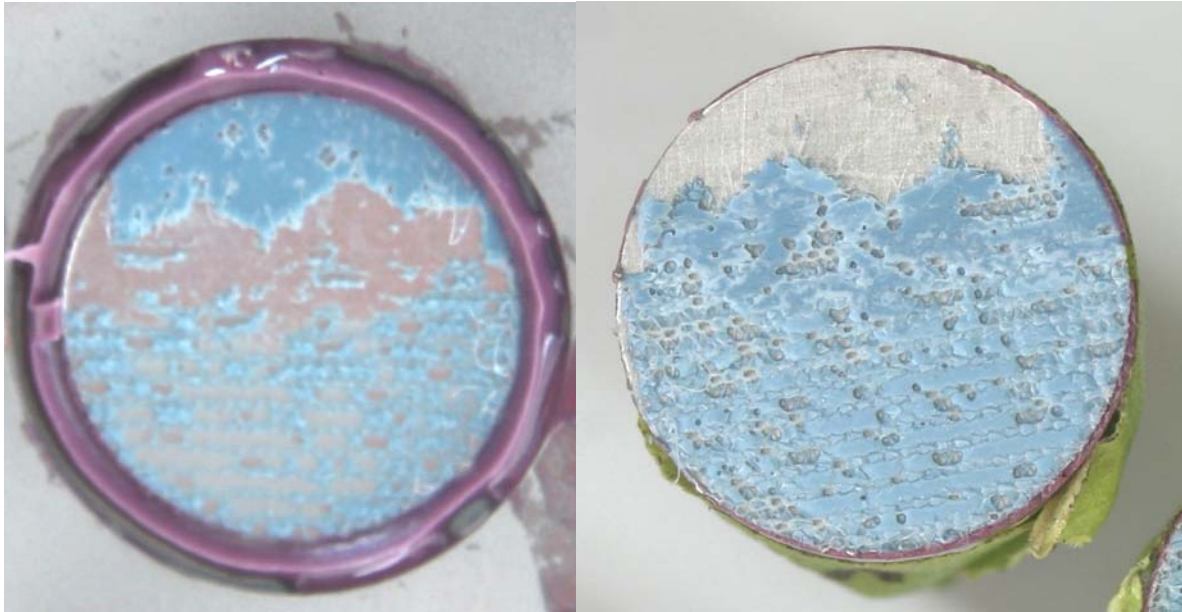
The final category of fracture surface identified, leading to lower localised repair strength, was observed for regions where the grit-blasting coverage appeared to be inadequate, highlighted by grey in Table 4. An example is shown in Figure 20, where Scotchbrite abrasion lines are clearly visible, suggesting that the level of grit-blasting was inadequate. Whilst the lightly grit-blasted region led to a clear reduction in stub strength, it did not appear to be the cause of the lowest strength reductions. The causes of low grit-blast coverage could potentially be related to difficulties with the equipment, which has been identified previously for wedge test samples prepared at Amberley over a number of

Figure 20 Test 145-29A, aircraft side on the left, and test stub (doubler) on the right. Close inspection of the test stub reveals Scotchbrite abrasion lines, suggesting that the level of grit-blasting was inadequate.

years [8]. An inspection tool, the BYK Gardner Micro TRI Gloss® gloss-meter, had previously been identified as being suitable for indicating whether aluminium surfaces have been adequately grit-blasted as part of the RAAF process for preparing adhesively bonded repairs [9]. Incorporation of this tool in pre-bond quality assurance testing would be expected to improve the quality of adhesively bonded repairs.
